# Identification of Contamination on Welding Wires Using Cross-Platform Techniques in SEM and Mass Spec

## Introduction

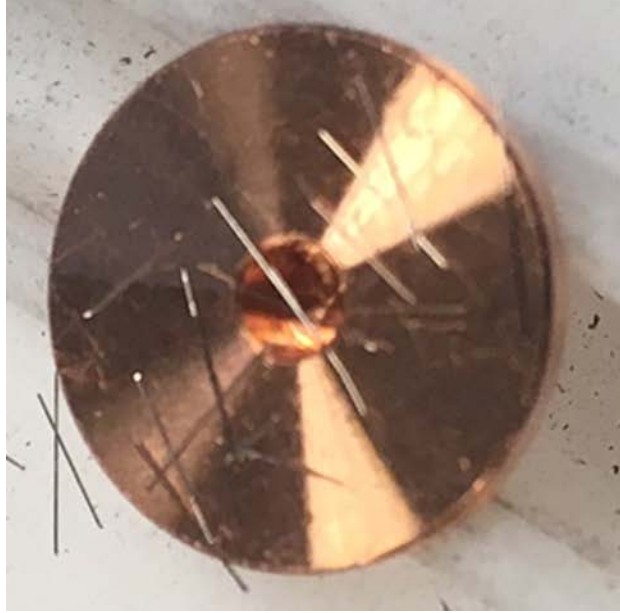
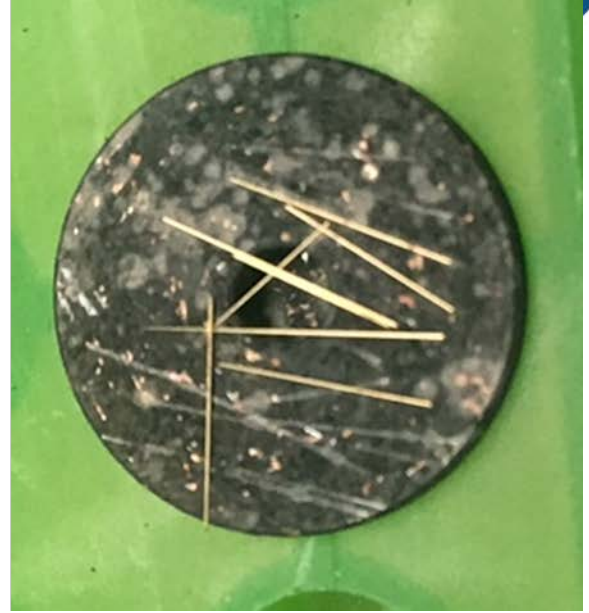
Figure 2. Segments of welding wire placed on the surface of the copper sample stages for the IonRocket. The left figure shows the wires placed on a fresh, clean sample stage, and the right side shows wire segments on the surface of a copper sample stage that was oxidized after heating to 600°C.

Scissors were used to cut small segments of wire (a few millimeters in length) that were placed onto the disposable copper sample stage for the *IonRocket*. Figure 2 shows the wire segments on the surface of the copper sample stage both before and after heating. The *IonRocket* was oven was positioned directly under the DART ion source, and a glass tee was used to sample the gases desorbed from the sample into the DART helium gas stream. The *IonRocket* was programmed with a temperature ramp to heat the sample from ambient temperature to 600°C in 6 minutes.

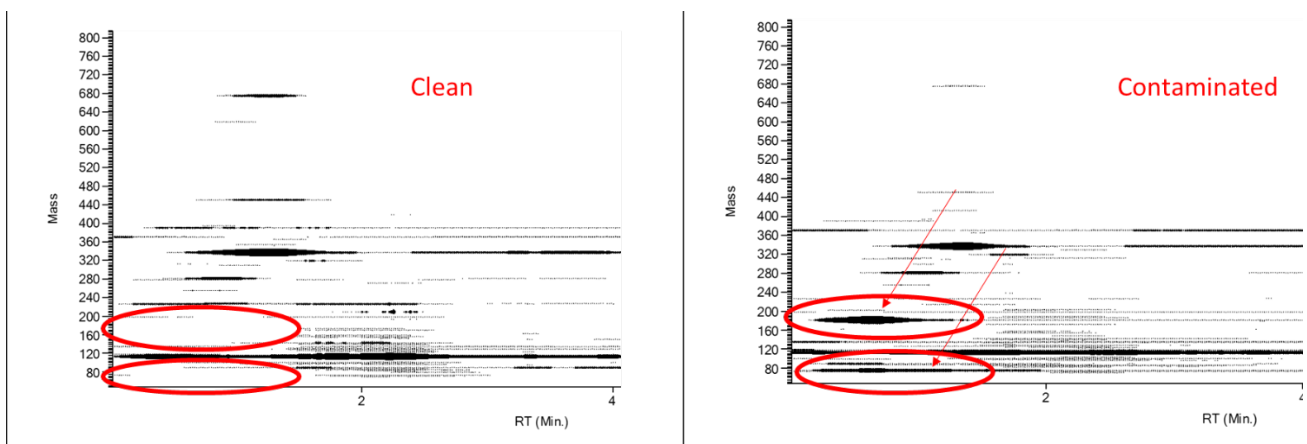
Figure 3. Comparison of the 3D plots for thermal desorption of clean (left) and contaminated (right) wires shows the presence of peaks at nominal  $m/z$  76 and  $m/z$  182 in the contaminated wires that are not present in the clean wires.

The 3D plots for clean and contaminated wires shown in Figure 3 provide an overview of the mass spectral analysis. The x-axis for each 3D plot indicates time and temperature. At a heating rate of 100°C min<sup>-1</sup>, 2 minutes is equivalent to 200°C, 4 minutes corresponds to 400°C, and 6 minutes corresponds to 600°C. The y-axis represents the mass-to-charge ratios ( $m/z$ ), and darker spots indicate higher relative abundance for the detected ions.

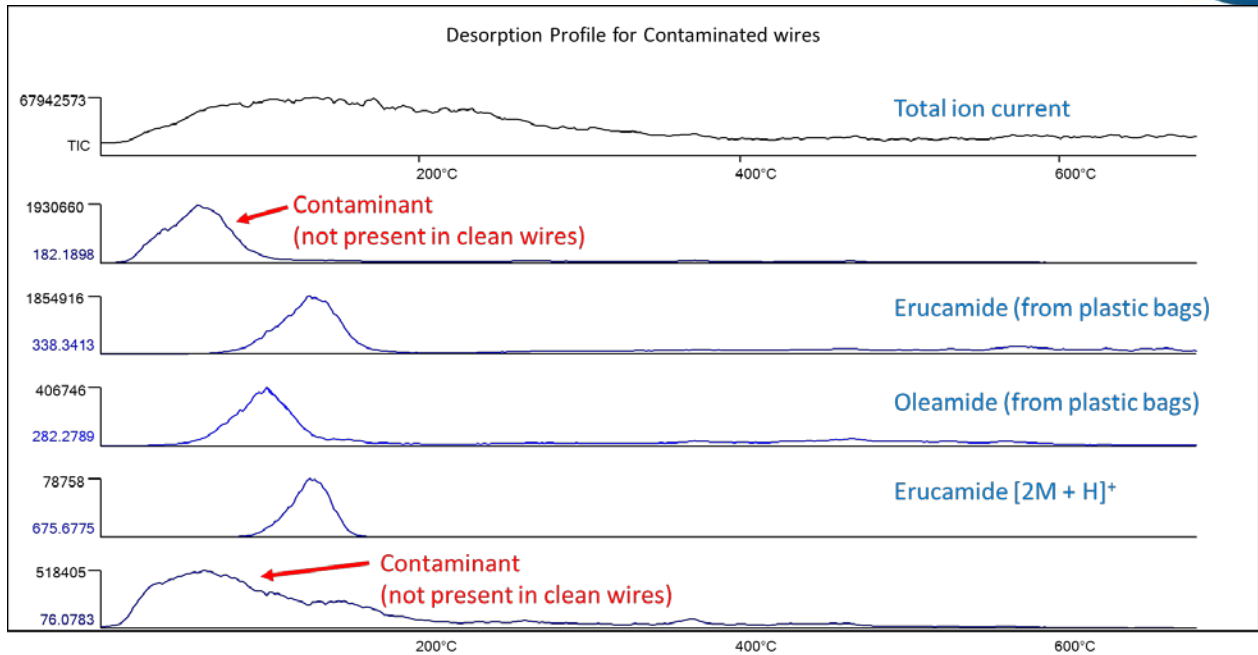
Figure 4. Thermal desorption profiles for selected components. Erucamide and oleamide are slip agents found on both clean and contaminated welding wires from the plastic bags used to ship the wires. The peaks at  $m/z$  76.0783 and  $m/z$  182.1898 were observed on the contaminated wires, but not on the clean wires.

The temperature profiles for selected contaminants in the plastic bags containing the welding wires and the compounds found only on the contaminated wires are shown in Figure 4. Examination of the mass spectra at time 0.6 minutes shows that major peaks are present in the contaminated wire, but not in the clean wire, at  $m/z$  182.1898 and  $m/z$  76.0751. The mass spectrum in Figure 5 shows the peaks present in the contaminated wire that are not present in the clean wire. Exact mass measurements with isotope matching provide elemental compositions for each peak that are consistent with compounds used in metal working fluids. For example, the base peak at  $m/z$  182.1898 is identified as protonated  $C_{12}H_{23}N$  (dicyclohexylamine), the peak at  $m/z$  76.0751 is identified as protonated  $C_3H_9NO$  (2-methylaminoethanol) and other compounds are tentatively identified as protonated 2-ethylaminoethanol, 2-butylaminoethanol, morpholine, 2-butoxyethanol, and cyclohexylamine based on their elemental compositions.
